**Cultural Heritage Property  
Maintenance and Reuse Plan:  
5193 Tremaine Road, Milton,  
Ontario**

FINAL REPORT

October 15, 2021

File: 160960844

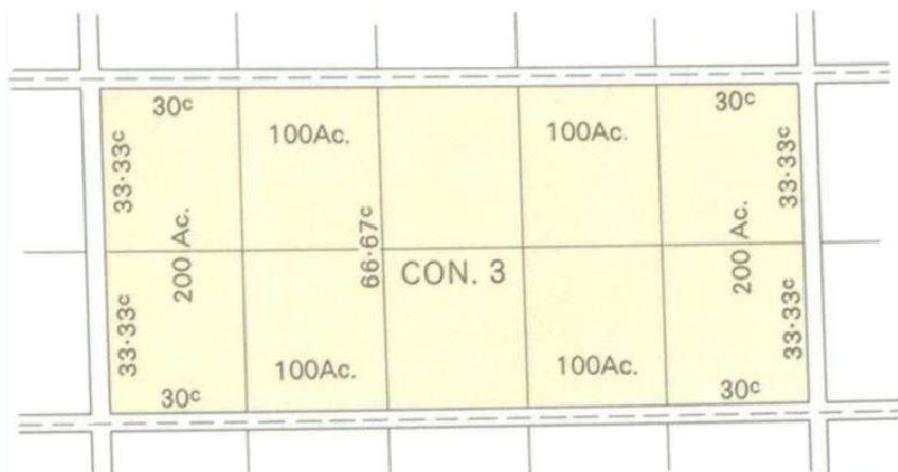
The Township of Trafalgar was surveyed in two parts. The first survey was completed in 1806 by Samuel Wilmot following the purchase of land near Lake Ontario from the Mississaugas in 1805. This part of the township, referred to as the Old Survey, was surveyed in the single front system. Prior to the first survey, as early as the 1790s, Euro-Canadian squatters were noted in the township (Case 1970). The township was named Trafalgar in honour of the Battle of Trafalgar, a naval campaign of the Napoleonic Wars which took place on October 21, 1805 when the Royal Navy battled a combined fleet of French and Spanish ships. The battle resulted in a widely celebrated British victory under the leadership of Vice-Admiral Horatio Nelson, who was mortally wounded in battle. The Township of Trafalgar and the adjacent Township of Nelson were named in honour of the victory (Gardiner 1899:243-244). The remainder of the township was purchased from the Mississauga in 1819 and surveyed in the double front system (Plate 1). Land surveyed using the double front system divided lots into 200-acre parcels with allowances for roads located in front of each concession and every fifth or sixth lot (Weaver 1968). The property is located within the portion of the township surveyed in the double front system (Case 1970).

**Plate 1: The double-front survey system (Dean 1969)**

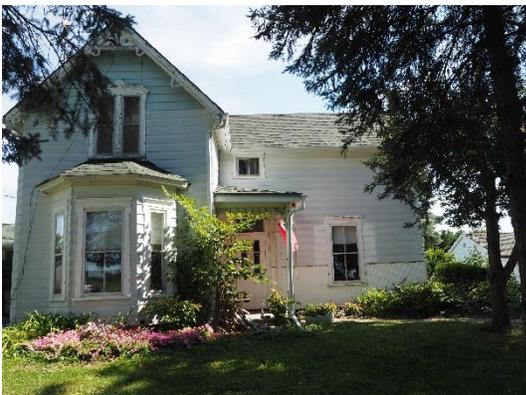
The residence at 5193 Tremaine Road is a one and one half storey structure with a cross gable roof. The roof is clad in asphalt shingles. The exterior of the residence is clad in modern vinyl siding. The front (southwest) façade features a bay window with 2/2 windows with wood frames, a covered front entrance, and a two over two wood frame window on the first storey, with a large window with a large four pane window and one small window on the upper storey (Plate 2). The front facing gable has bargeboard in the peak and the large window on the upper storey includes a decorative wood window surrounds and surround with a wooden sill (Plate 3). The front entrance has a rectangular transom window above the door and decorative wooden trim on the awning (Plate 4). The stone foundation can also be seen on this façade (Plate 5).

**Plate 2: Southwest façade, looking northeast**

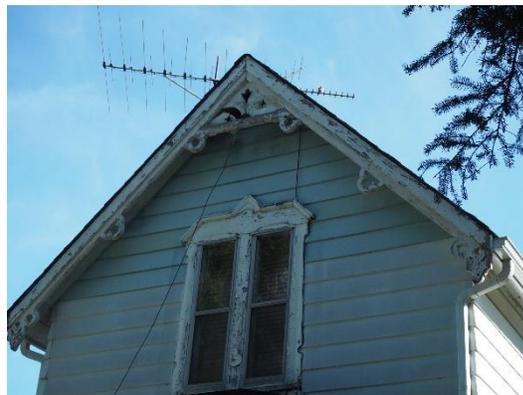
**Plate 3: Bargeboard and decorative wooden window surround, southwest façade, looking north**

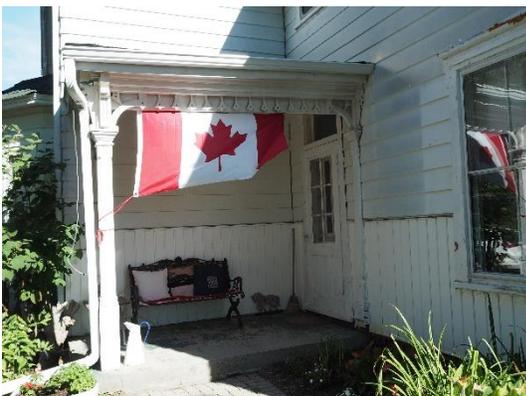
**Plate 4: Front entrance and covered porch with decorative trim, southwest façade, looking north**

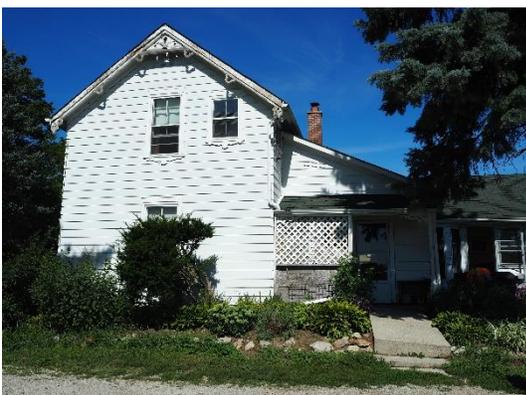
The southeast façade includes a side gable portion with three four pane windows, a shed roof portion with a second covered entrance, and a sunroom addition (Plate 6 and Plate 7). The side gable portion is one-and one-half stories with bargeboard along the roof peak and decorative wooden window surrounds. The shed roof portion is one storey with wooden brackets in the corners of the awning. The sunroom addition is also one storey with a side gable roof and this portion of the structure is set on a poured concrete foundation (Plate 8).

**Plate 6: Southeast façade, looking northwest**

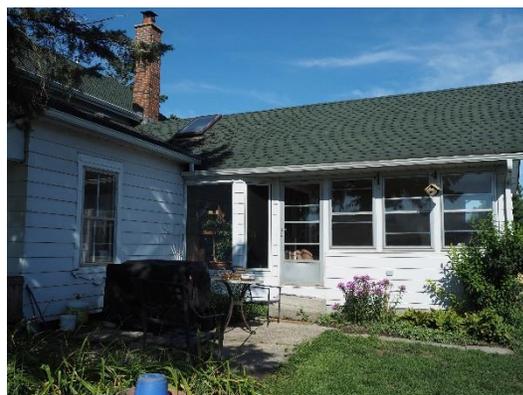
**Plate 7: Gable roof sunroom addition, southeast façade, looking northwest**

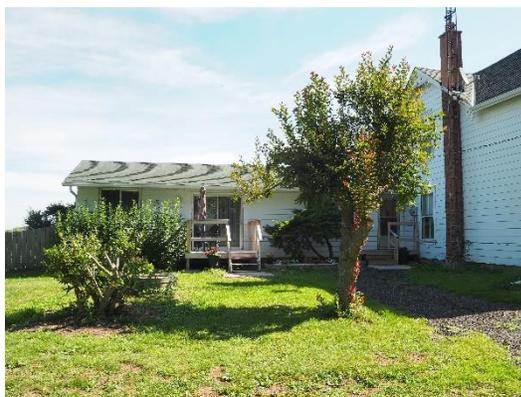
The southeast façade contains a gable roof addition. The southwest façade of this addition includes two horizontal sliding windows as well as a patio door and a door which both have small wooden decks (Plate 9). The southwest façade of the older portion of the residence includes bargeboard in the peak of the side gable, a brick chimney with different types of brick on the upper and lower portions, and two four pane windows, one on the first storey and one on the upper, both with decorative surrounds like those on the southeast façade. The addition's concrete block foundation and another brick chimney can be seen on the northwest façade (Plate 10 and Plate 11).

**Plate 9: Southwest façade of gable roof addition attached to northwest side of residence, looking northeast**

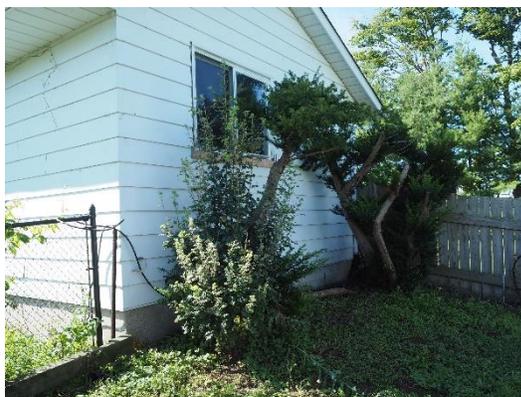
**Plate 11: Northwest façade of gable roof addition, looking south**

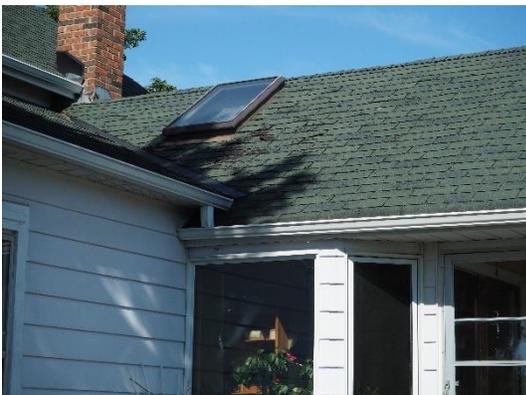
**Plate 12: Localized areas of lifting shingles**

The house overall appears to be in good condition. The house is clad in vinyl siding which is intact, and the chimney is in good repair. Much of the stone foundation is obscured by vegetation, but localized gaps in the mortar were visible on the southwest (front) façade. Based on the interior view of the basement, there appear to be some gaps in the mortar and around the windowsills that may be allowing water into the basement. The roof has lifting shingles in localized areas and is due for replacement (Plate 12).

The roof shows signs of lifting shingles and given the water staining in the upstairs master bedroom, it would benefit from new roofing materials.

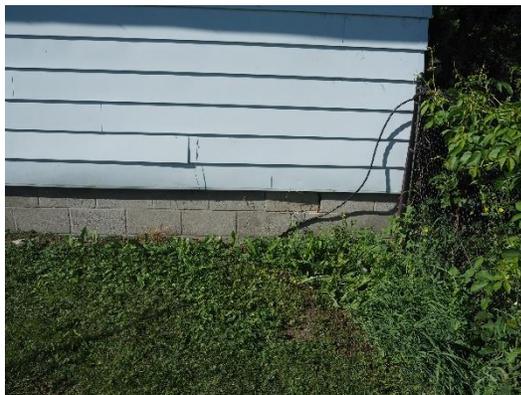
**Plate 13: Settling and refilled cracks in the addition's foundation**

On the northwest elevation, the downspout is draining directly to the foundation. There is settling evident in the corner of the northwest foundation of the addition, but cracks have been refilled (Plate 13). At the northwest window of the addition, there is evidence of water intrusion, with the possibility of water getting in behind the siding (Plate 14).

There are some localized gaps in the foundation, particularly on the front (southwest) façade. These may be repaired and steps taken to direct potential sources of water away from the foundation. This is applicable to the northwest façade as well. Although the addition is not a heritage attribute, the downspout could be redirected away from the house to prevent water damage to the wider structure. There is evidence of water intrusion at the window on this façade and this may be further investigated to see if water has penetrated behind the siding and should be repaired to prevent additional water damage.

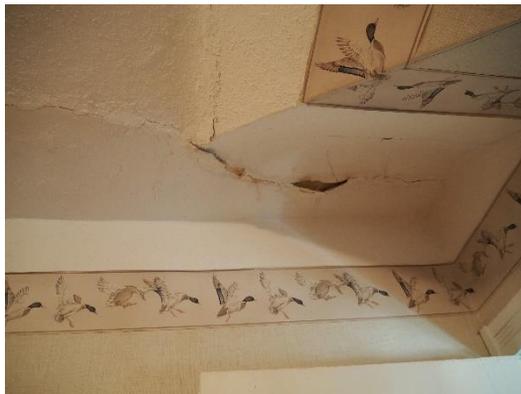
**Plate 15: Water staining and cracking in second storey master bedroom**

In the interior, there is evidence of plumbing leaks from the second storey bathroom, and evidence of water staining in the first-floor dining room ceiling and second-floor master bedroom ceiling (Plate 15). Some localized settlement cracks in the plaster are visible in the entrance hallway and 20<sup>th</sup> century addition (Plate 16). The interior windows in the living room have been caulked and there is some evidence of moisture around the window frames (Plate 17).

The bathroom has a plumbing leak which should be addressed to avoid interior water damage.

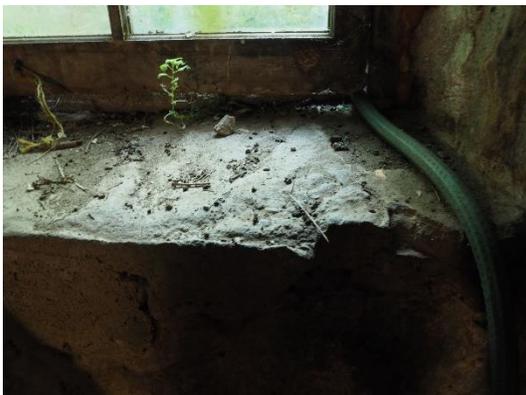
**Plate 18: Gaps around basement windows**

The basement shows evidence of water damage, and there are small visible gaps around the windows that may allow water through (Plate 18). The tenant of the property stated that there is water in the basement that needs to be pumped out in the spring which appears to enter the house following the path of the incoming wire conduit. In the basement, there appears to be some live sections of knob and tube wiring, connected to basement lights and the line to the freezer and upstairs dining room (Plate 19). A forced air duct rests on a knob and tube line (Plate 20). Several metal support posts have been installed in the basement, resting on concrete blocks (Plate 21).

There is evidence of water in the basement and a damp foundation, and the tenant noted annual water intrusion in the basement in the spring. Given this is a recurring problem that may be related to spring runoff, measures to reduce the amount of water surrounding the house are recommended, including inspection of the gutters and downspouts to avoid overflows, and the installation of a French drain or basement waterproofing with sump pit and sump pump to redirect water away from the foundation.
