**CN Milton Logistics Hub -
Letter of Intent to Implement Offsetting Measures**

FINAL REPORT

Stantec Consulting Ltd.

May 18, 2021

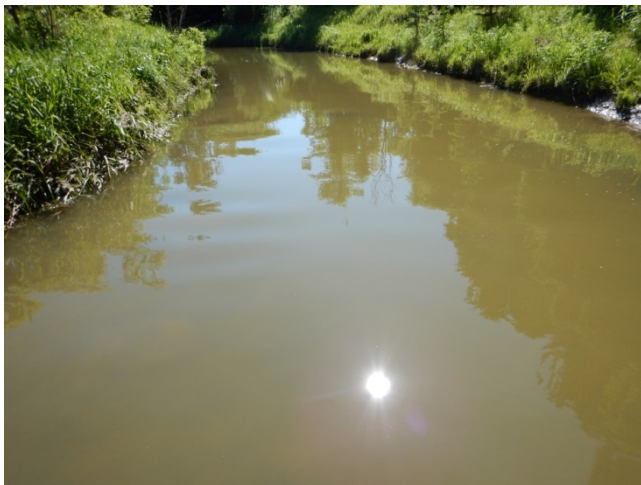
Photo 9: Transect 2 – Channel bank.

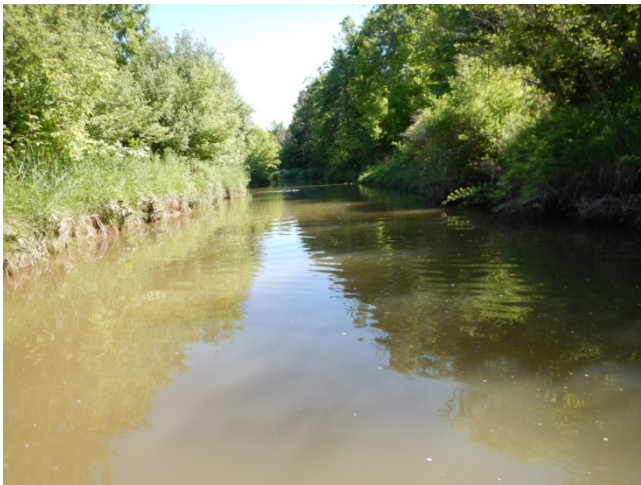
Photo 10: Transect 2- Turbid water.

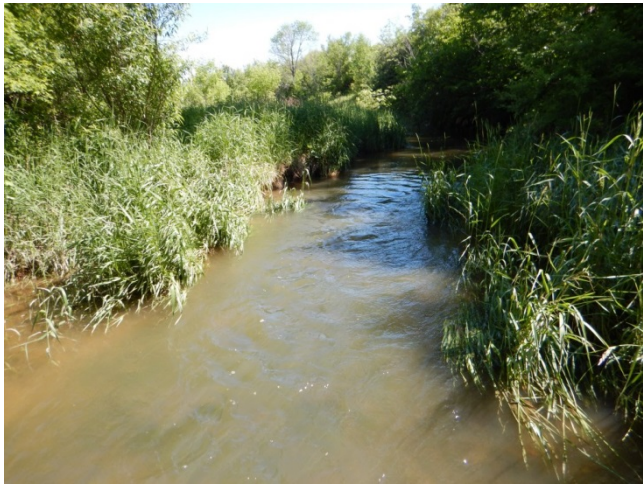
Photo 15: Transect 3 – Substrate and vegetation at bank.

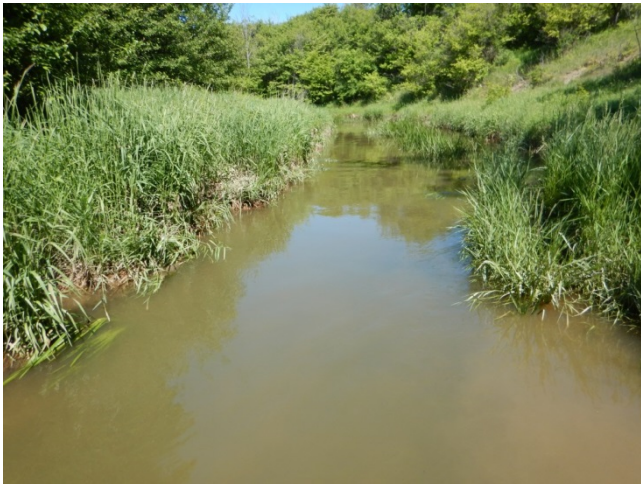
Photo 20: Transect 4- Channel substrate.

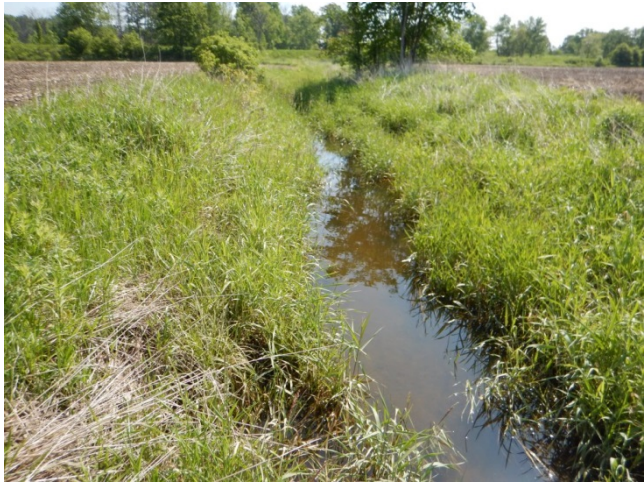
Photo 37: Between Transect 4 and 5 - facing northwest; surficial drainage off adjacent field.

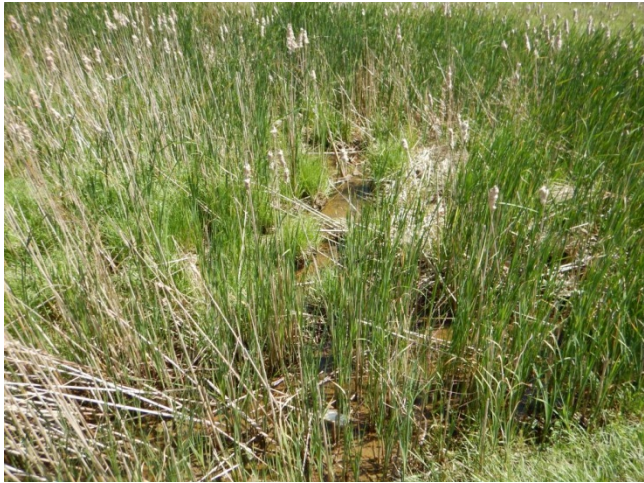
Photo 43: Transect 5- Facing upstream (east), towards culverts under CN rail line (end of reach).

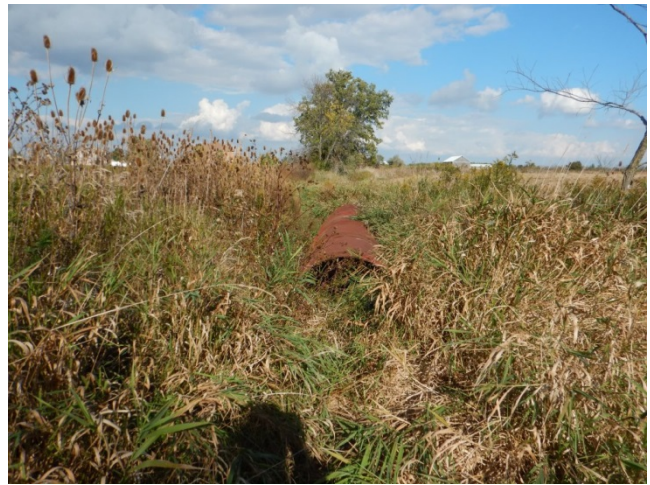
Photo 1: Upstream limit of Tributary C within PDA approximately 400 m north of Tremaine Road. Facing downstream (south) showing channel overview through grass field.

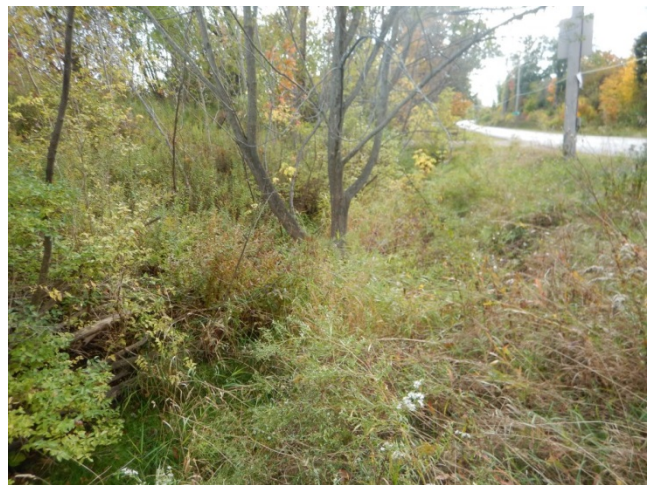
Photo 3: Upstream limit of Tributary C within PDA approximately 400 m north of Tremaine Road showing substrate and channel.

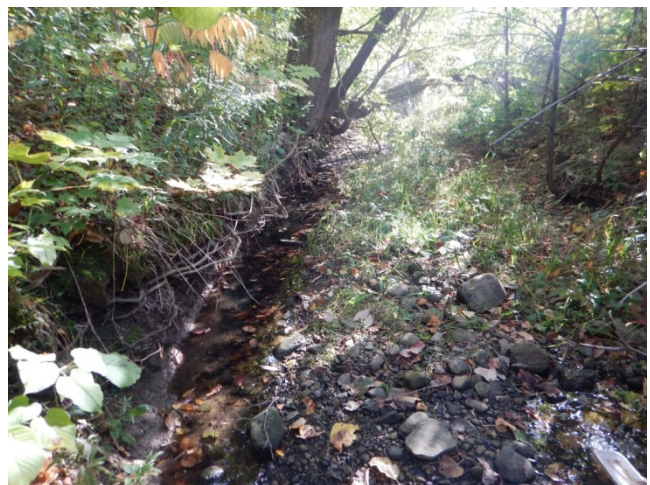
Photo 5: Reach of Tributary C approximately 100 m north of Tremaine Road facing downstream (south) showing substrate and channel overview.

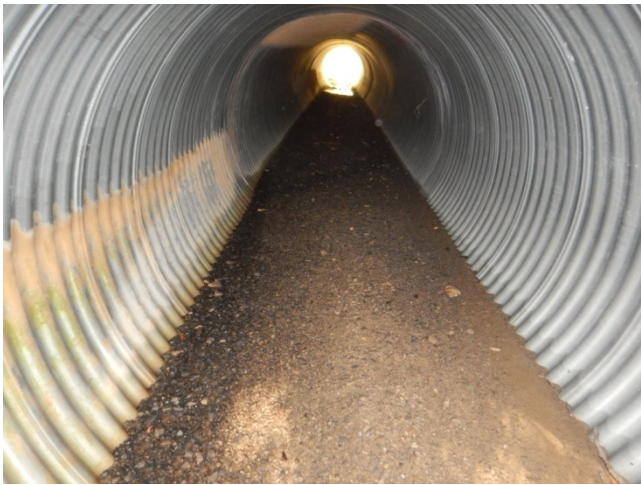
Photo 6: Reach of Tributary C approximately 20 m north of Tremaine Road facing downstream (south) showing substrate and channel overview.
