Cultural Heritage Property Maintenance and Reuse Plan: 4393 Tremaine Road, Milton, Ontario

FINAL REPORT

October 15, 2021 File: 160960844

Stantec Consulting Ltd. 600-171 Queens Avenue London, Ontario N6A 5J7

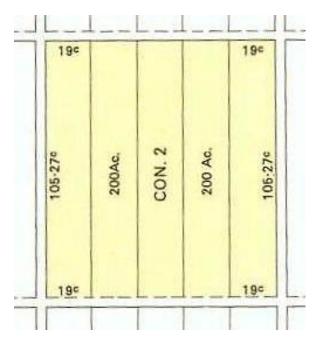
Plate 1: The single front survey system (Dean 1969)

The Township of Trafalgar was surveyed in two parts. The first survey was completed in 1806 by Samuel Wilmot following the purchase of land near Lake Ontario from the Mississaugas in 1805. This part of the township, referred to as the Old Survey, was surveyed in the single front system (Plate 1). The single front survey system was popular between 1783 and 1818 and used extensively along the north shore of Lake Ontario (Dean 1969). The property at 4393 Tremaine Road is part of the Old Survey. Prior to the first survey, as early as the 1790s, Euro-Canadian squatters were noted in the township (Case 1970). The township was named Trafalgar in honour of the Battle of Trafalgar. The battle was part of the naval campaign of the Napoleonic Wars and took place on October 21, 1805 when the Royal Navy battled a combined fleet of French and Spanish ships. The battle resulted in a widely celebrated British victory under the leadership of Vice-Admiral Horatio Nelson, who was mortally wounded in battle. The Township of Trafalgar and the adjacent Township of Nelson were named in honour of the victory (Gardiner 1899:243-244). The remainder of the township was purchased from the Mississauga in 1819 and surveyed in the double front system (Case 1970).
